Department of
Resources Recycling and Recovery

March 28, 2025

Subject: Review of the November 26, 2024, Revised Soil Reaction Break/Barrier Plan for the Chiquita Canyon Landfill Subsurface Elevated Temperature (SET) Event

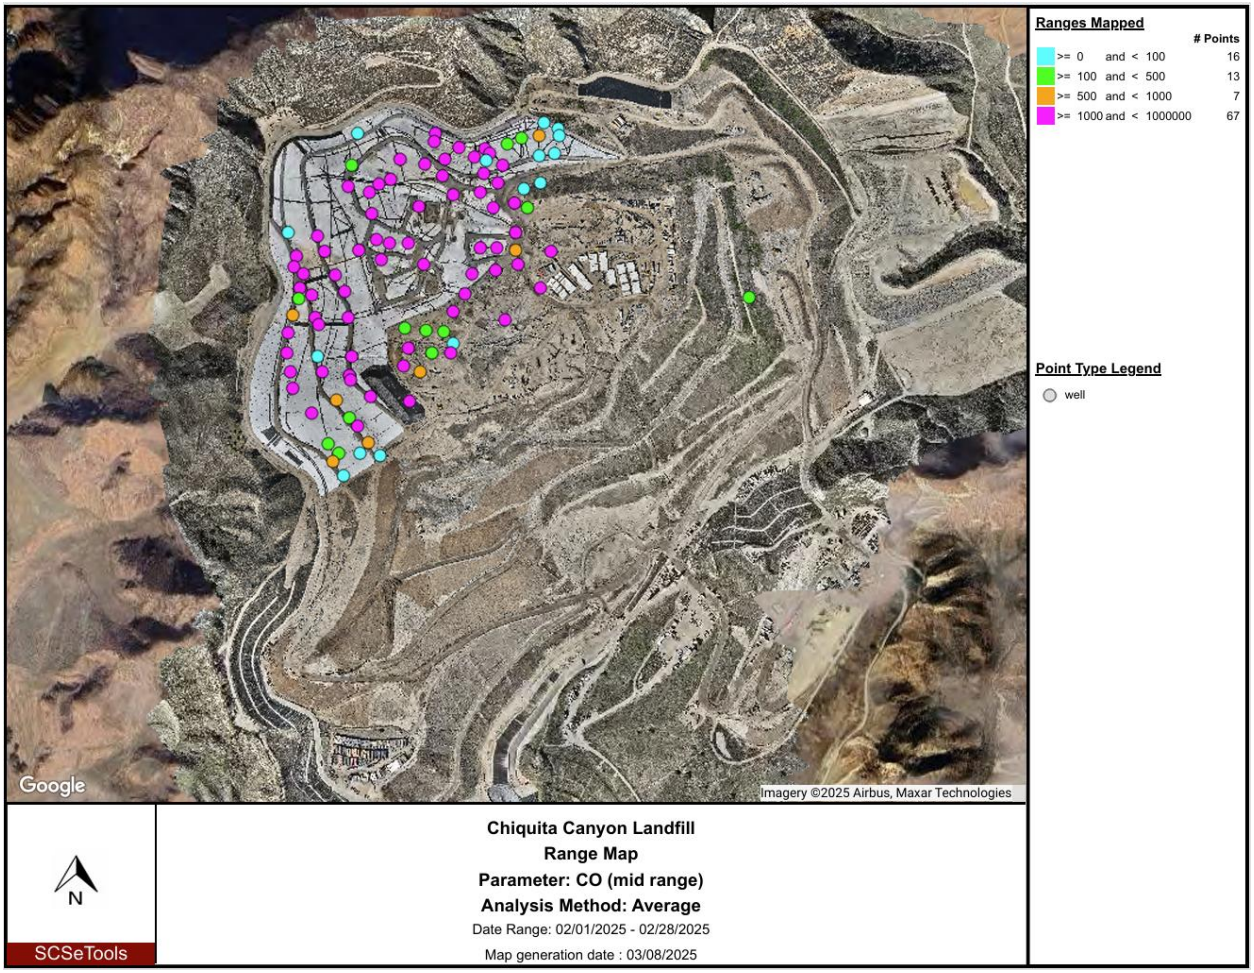
The Committee disregards the CO results, possibly because they assume this reaction is an unknown chemical reaction causing an ETLF event, rather than a smolder, SSO, or fire. Carbon monoxide concentrations have been used for over 40 years in the US and abroad as a measure to determine if a smoldering or SSO is extinguished. Carbon monoxide is also a sign of incomplete combustion, and the change of CO levels over time is a critical tool in determining the magnitude of the SET Event. This is also why USEPA requires CO measurements[10] at a wellhead or any point in the well greater than 170°F (76.7°C). CalRecycle staff is aware that CCL is tracking CO and providing a scale for intensity in SCSe Tool, but we are unsure why the Committee is disregarding a key metric. **Figure 1** provides the most current CO levels at the CCL.

Figure 1. Chiquita Canyon Landfill CO Range Map, March 8, 2025. (Source: SCSe Tools)

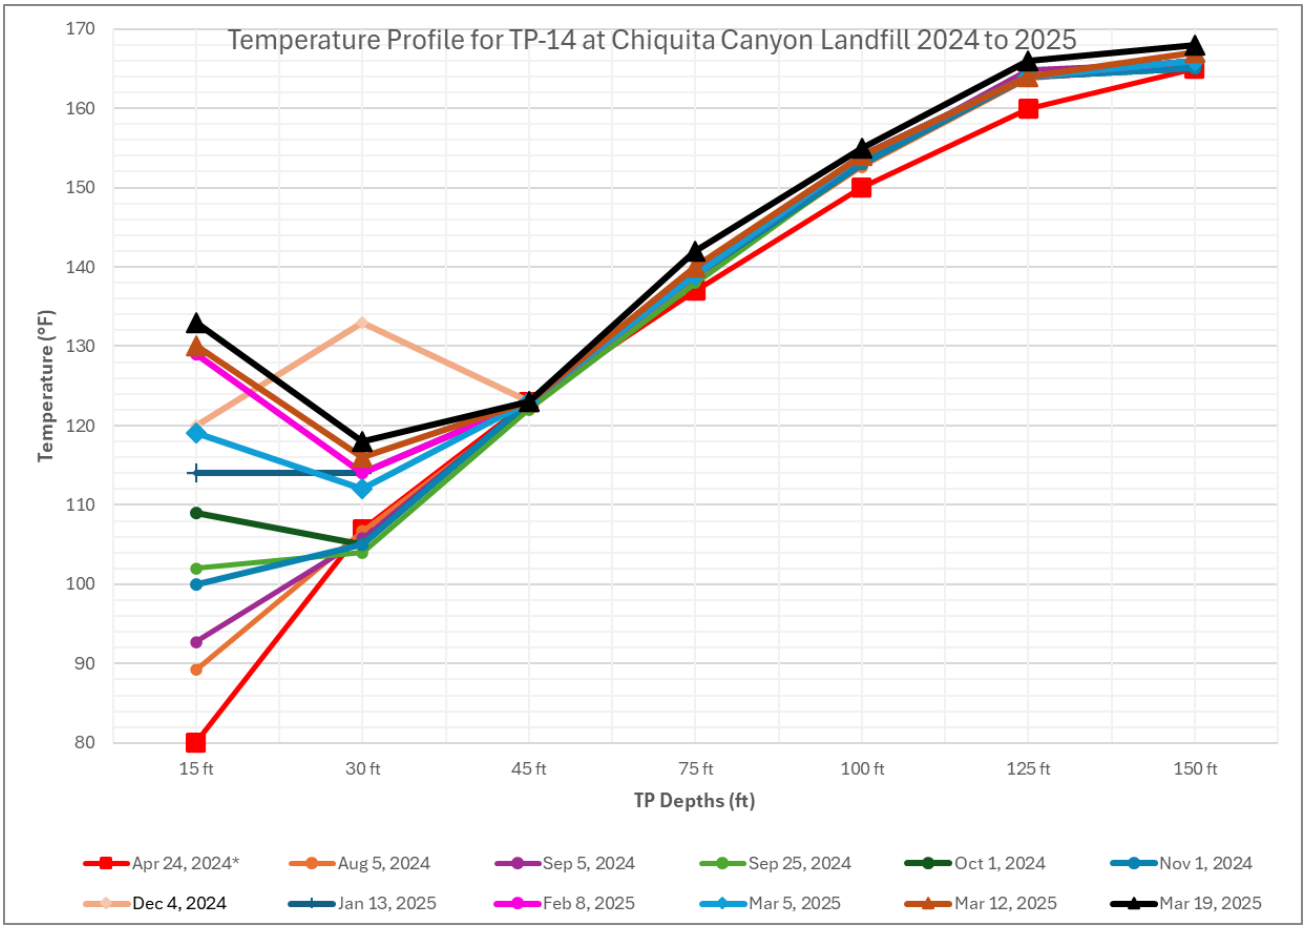
As an example of how wellhead temperatures can mask what is occurring in the waste, as shown in **Figure 2,** TMP-14 reported a temperature of 80°F (26.7 °C) on April 24, 2024, at the fifteen-foot probe. By March 19, 2025, the temperature at the 15-foot probe had increased to 133°F (56°C). This shallow temperature spike was not observed in gas well CV-1906, approximately 10 to 15 feet away, where the wellhead temperature was reported to be 68°F (20°C) on April 1, 2024, and 60°F (15.5°C) on March 19, 2025. There were also significant temperature swings in the wellhead temperature data for gas well CV-1906, where the temperature rose from 95°F (35°C) to 121°F (49°C) and then dropped to 73°F (22.7°C) within a month. However, all the wellhead temperatures are below the regulatory threshold and do not require further analysis. Data from TMP-14 indicated that on March 19, 2025, the temperature reached 133°F (56°C) and exceeded the 131°F (55 °C) threshold. CV-1906 is also experiencing a significant oxygen overdraw at this location. The percent oxygen has varied from 10.9 percent on March 4, 2024, to 18.7 percent on March 6, 2025. The average oxygen for the past year at this well is 8.4 percent. Continued high oxygen levels above 2 percent and temperature spikes will lead to a SET Event. This TMP and gas well are approximately 450 feet away from the CCL-defined reaction boundary and CalRecycle staff do not believe the shallow temperature increases are connected to the main reaction area. CalRecycle believes that the temperatures of 166 to 168°F (74.4 to 75.5°C) at the deeper probe (i.e., 125 to 150 ft) are connected. However, this data demonstrates that the operation of the GCCS must not sacrifice LFG operational objectives/standard operating procedures (i.e., limiting oxygen to 2 percent[15]) to control emissions and risk developing of new SET Events. **Table 2** and **Table 3** provide the LFG data and temperatures for gas well CV-1906 and TMP-14.

Figure 2. TMP-14 Temperature Profile Demonstrating a Shallow SET Event Developing at Chiquita Canyon, April 24, 2024, to March 19, 2025. (Source: SCS Engineers TMP Data)

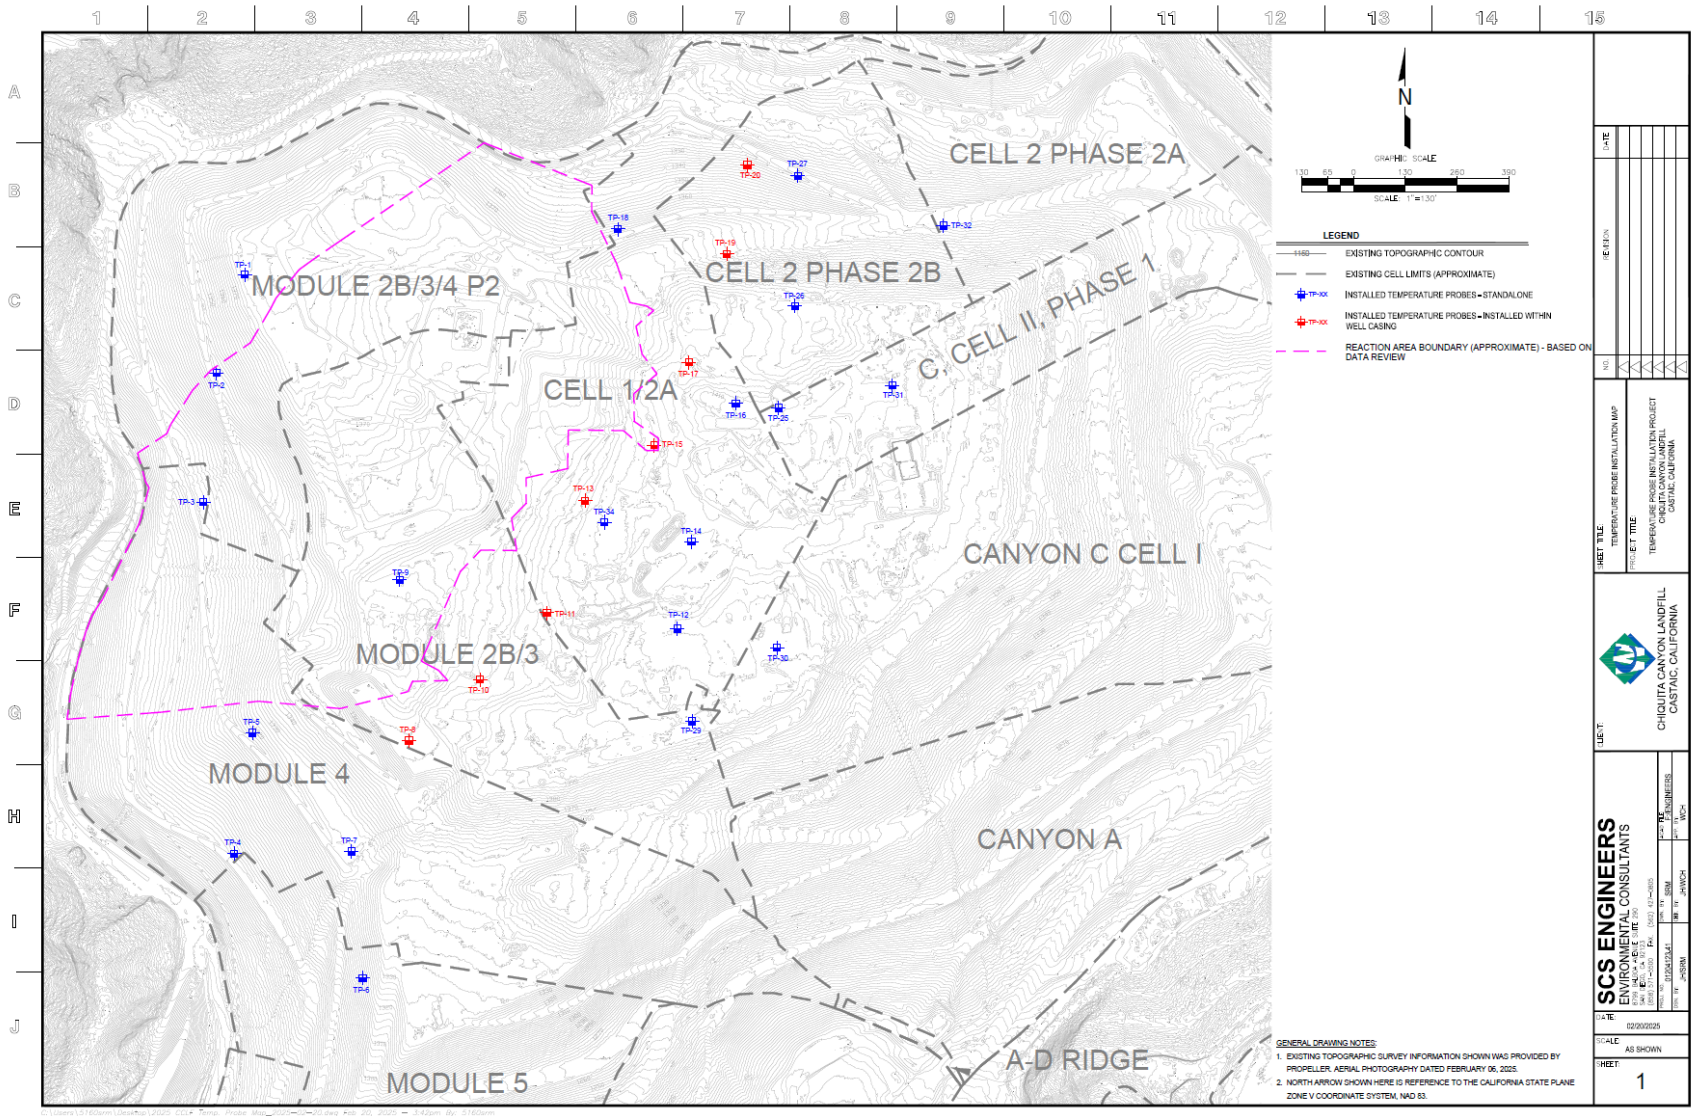
Figure 3. TMP Installation Map for Chiquita Canyon, 2024. (Source: SCS Engineers TMP Data December 2024)

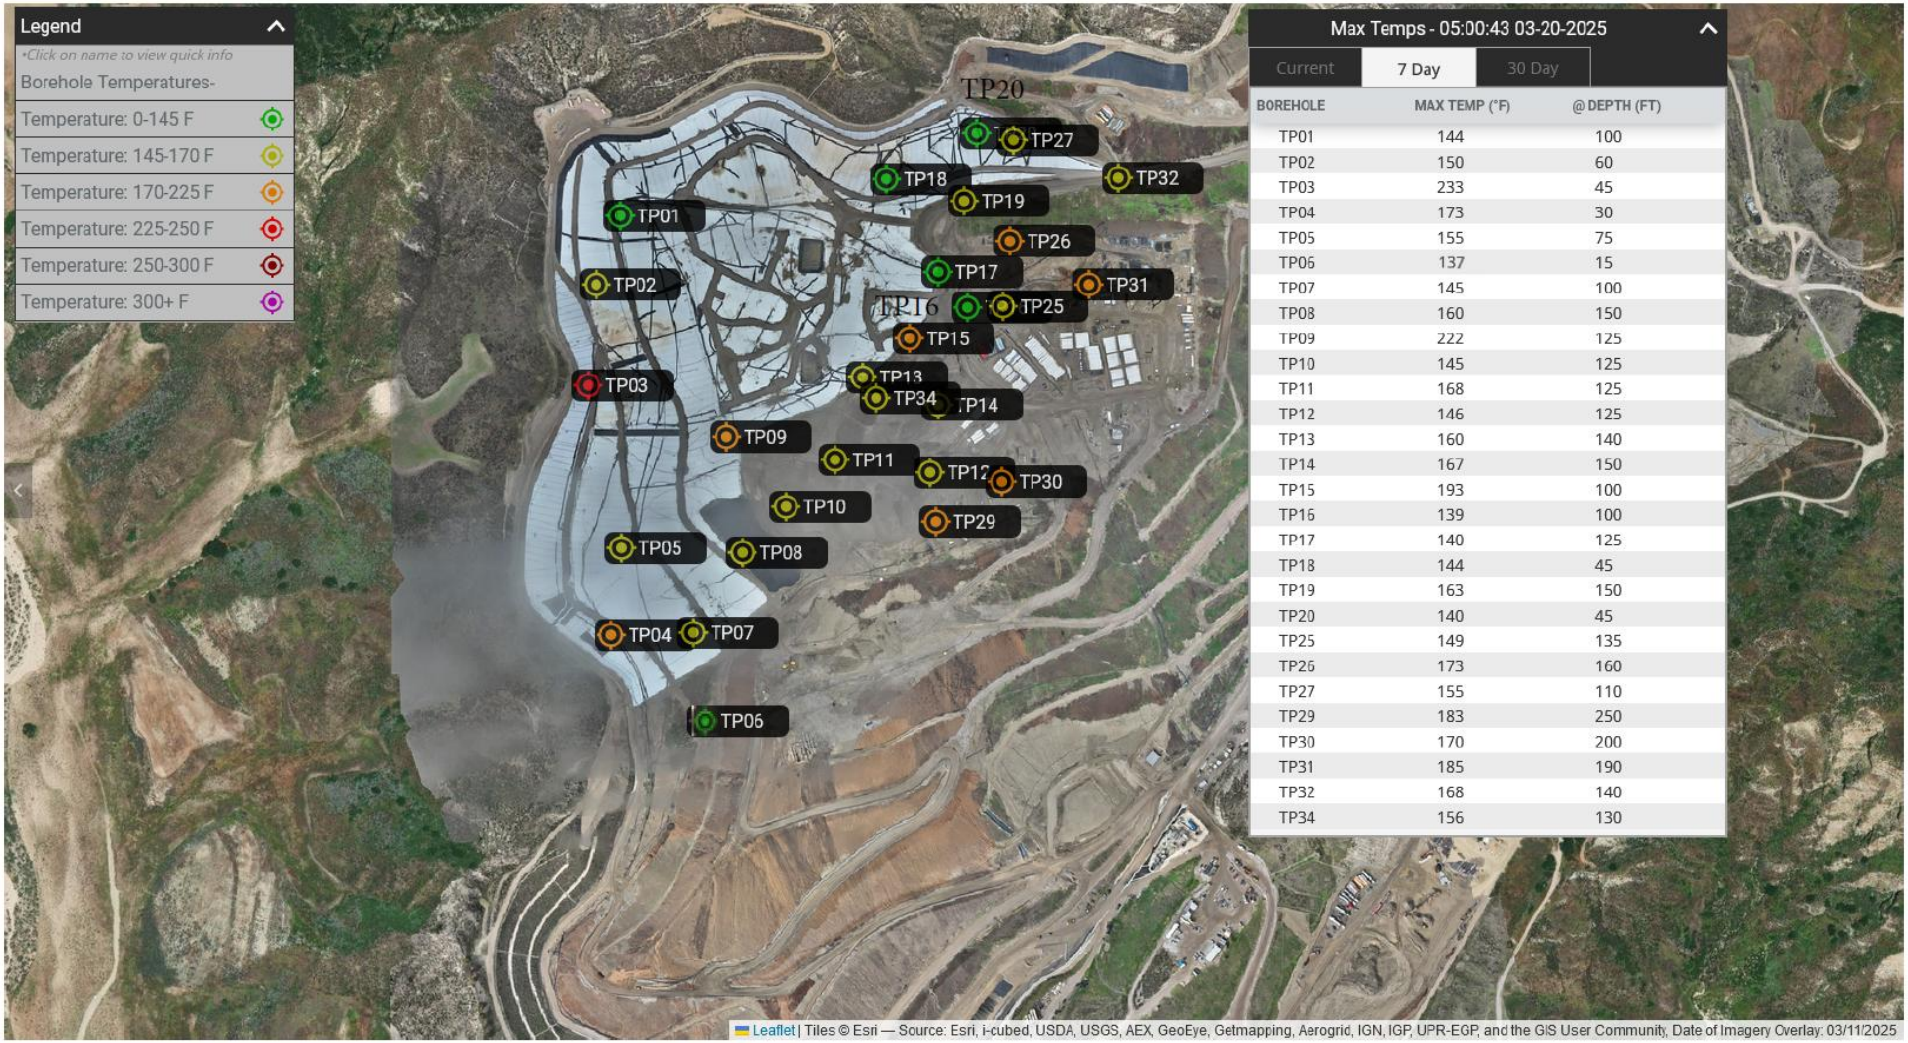
The Reaction Committee stated in November 2024, that the temperatures recorded by the 13 probes (TP-4, TP-6, TP-7, TP-8, TP-10, TP-11, TP-13, TP -14, TP-15, TP-17, TP-19, TP-20) outside the boundary during October 2024, are not indicative of a subsurface reaction and do not substantiate a decision to expand the boundary of the reaction area at this time. However, in January 2025, the CCL made an adjustment to the Reaction Area boundary that included TMP-15. **Figure 3** provides a map of the TMP's network as of December 2024, while **Figure 4** shows the most recent TMP network, which includes the seven installed TMPs (TP-25, TP-26, TP-29, TP-30, TP-31, TP-32) and the new Reaction Area boundary encompassing TP-15.

Figure 4. Revised TMP Installation Map Chiquita Canyon for 2025. (Source: SCS Engineers TMP Data March 2025)

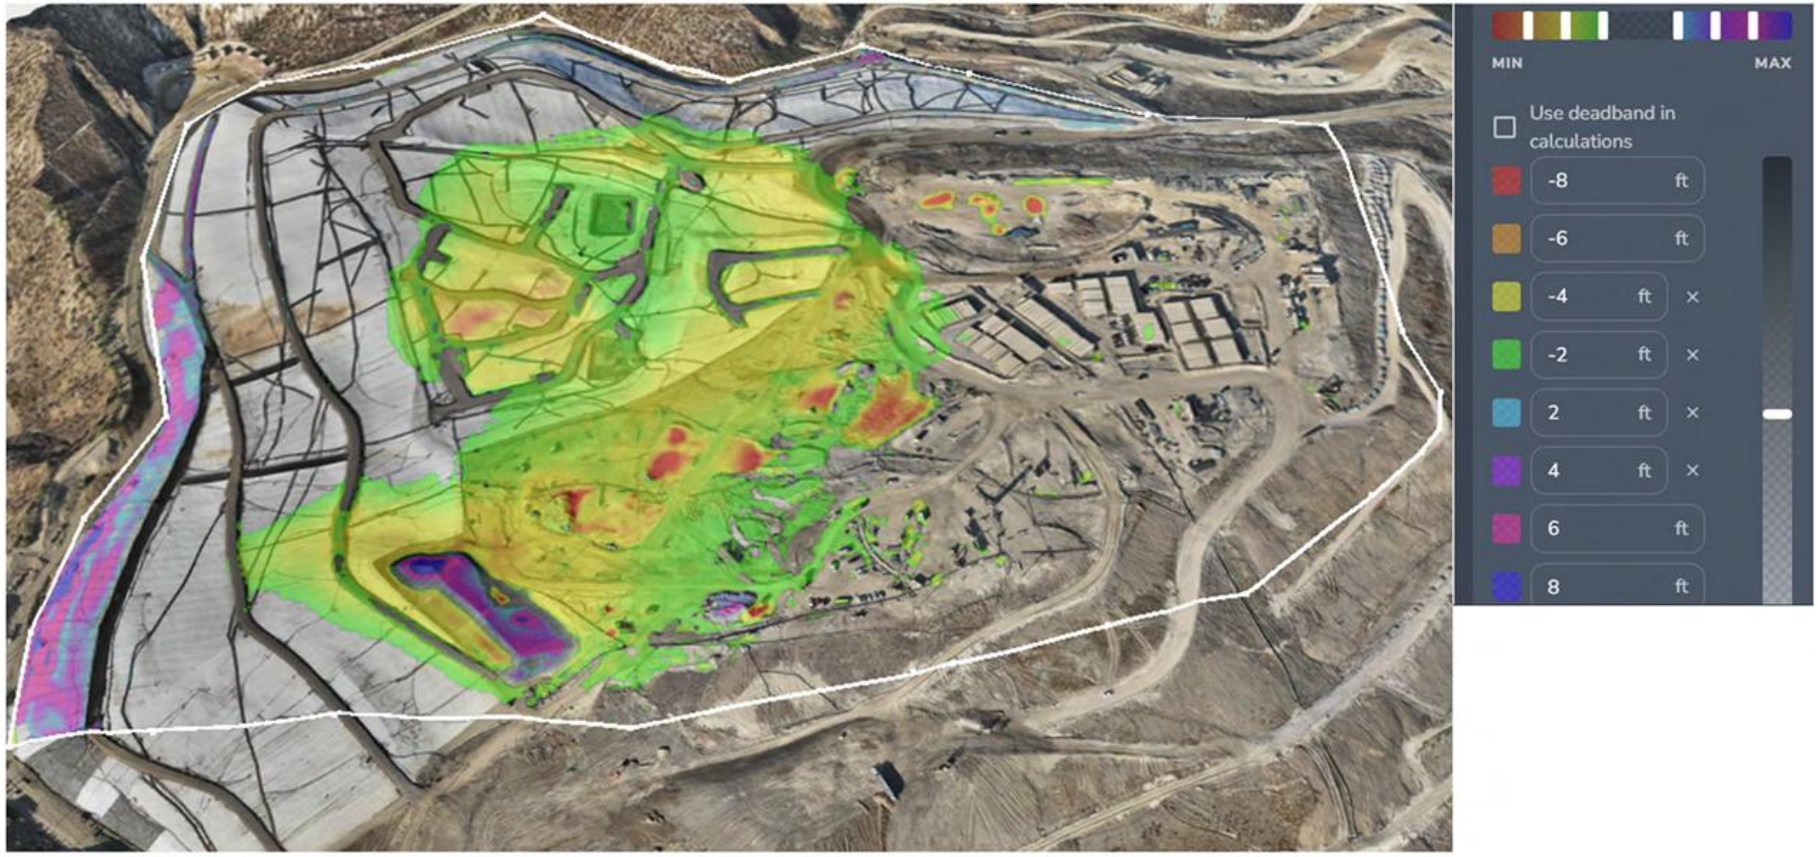
There are several ways to increase the degree of certainty in determining the magnitude of a SET Event. Without all the available data, the operator or regulator must evaluate primary indicators such as temperature, LFG gas data, CO, H_2, and physical signs of a SET Event. If other reports or data are available, the operator should analyze this data and compare it to the primary tool. Other data would include FLIR imagery with reference temperature scale, settlement, leachate and gas chemical characteristics, fissures, slope stability reports, additional temperatures from liquid pumps in wells, 2D and 3D temperature modeling, iospatch modeling, odors and emissions, leachate outbreaks and generation, and individual LFG gas plots. The CCL is using the isopatch software to track the settlement every quarter, as shown in **Figure 6**. They also track

Figure 6. CCL Isopatch Settlement Map, January 3, 2025 Survey Image. October 2, 2024 vs January 3, 2025. (Source: CCL February 2025)

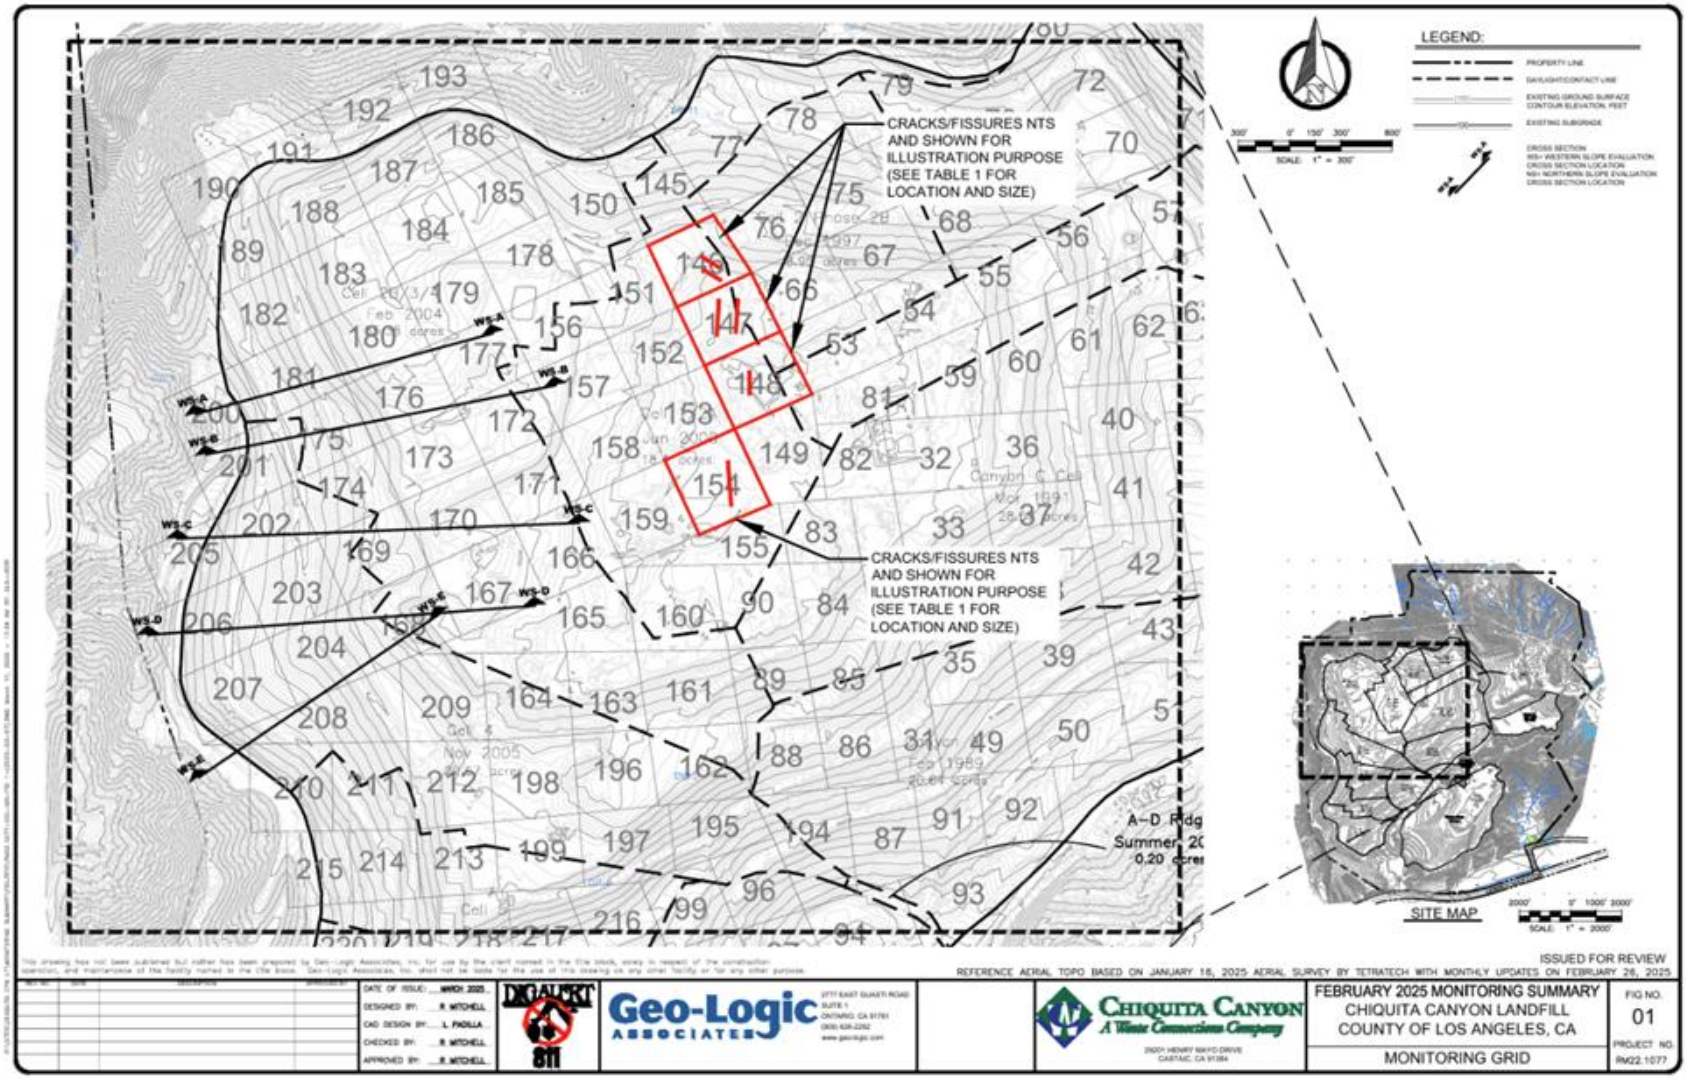
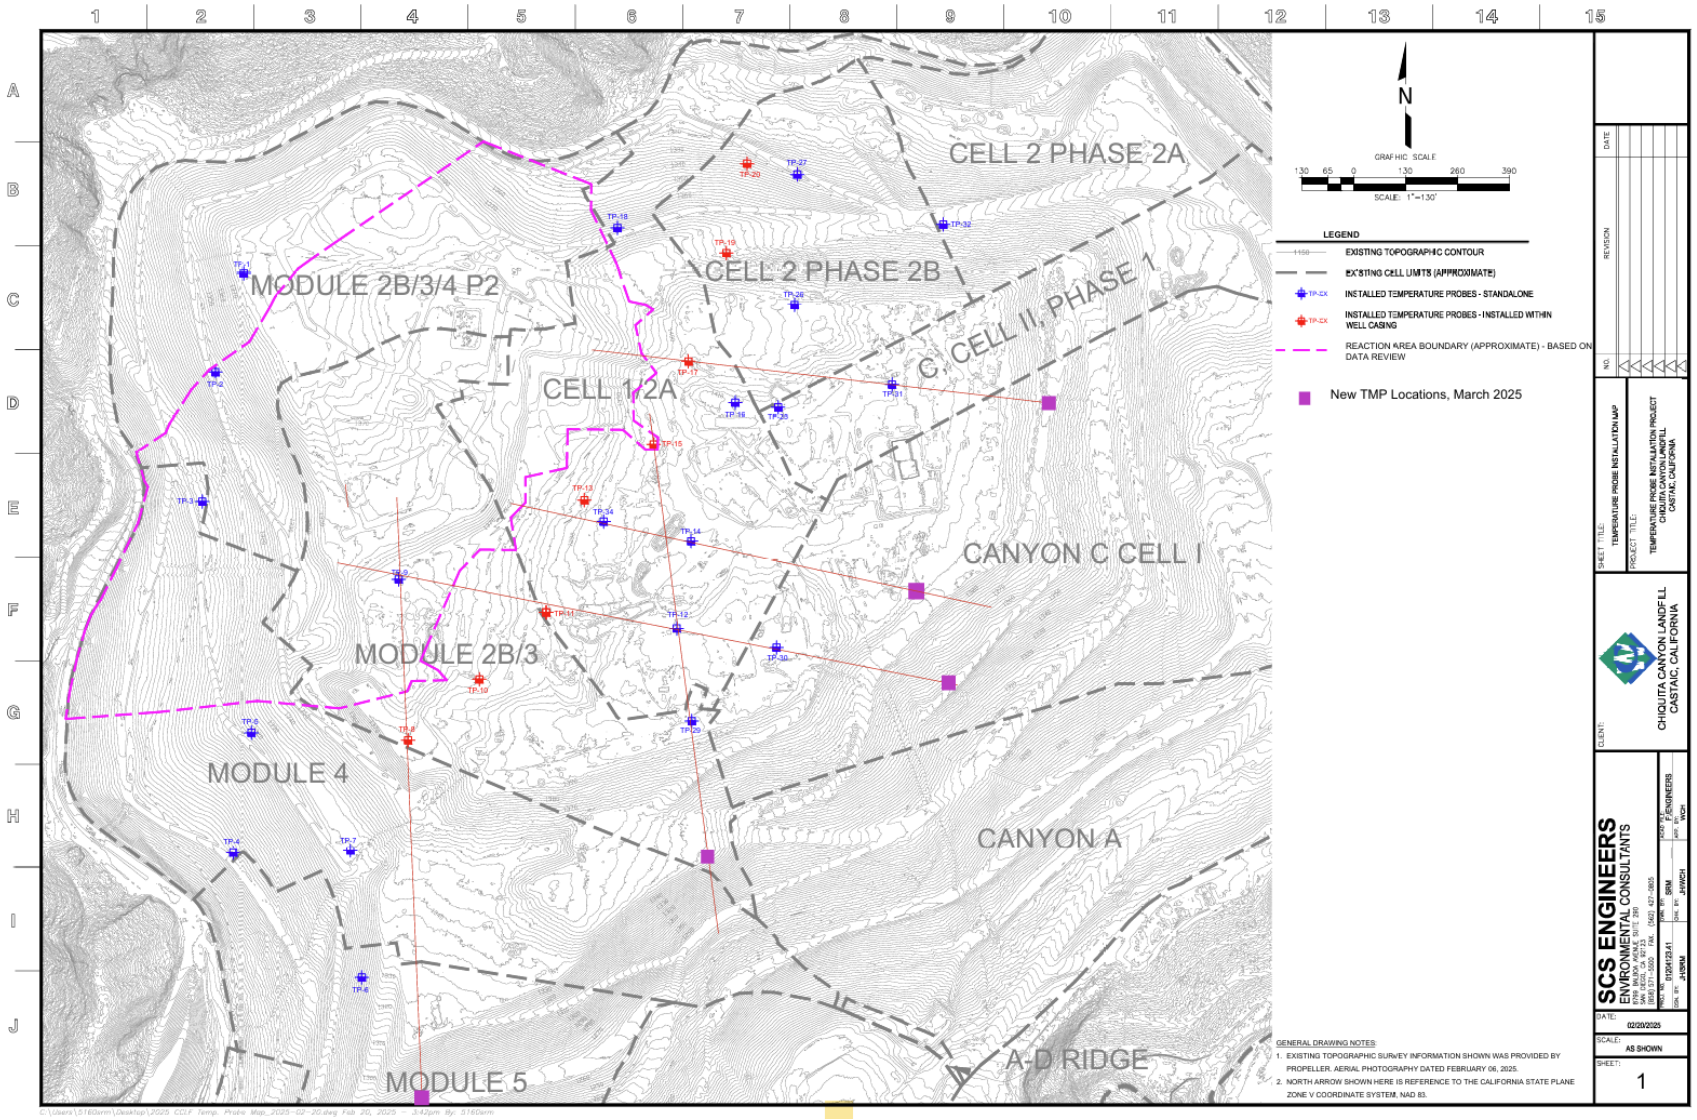
The CCL Settlement and Fissure Reports also align with the TMP temperature spikes data in grids. CCL's consultant, Geo-Logic Associates, provided a summary map of the recently occurring fissures in February 2025 (see **Figure 8**). Significant fissures and areas where the soil collapsed were documented in Grids 146, 147, 148, and 154. CalRecycle also reviewed FLIR data from October 2024; however, CCL has refused to provide the temperature layer on each photo. All data should be available.

Figure 8. Fissure and Crack Monitoring Report for February 2025. (Source: Geo-Logic Associates)

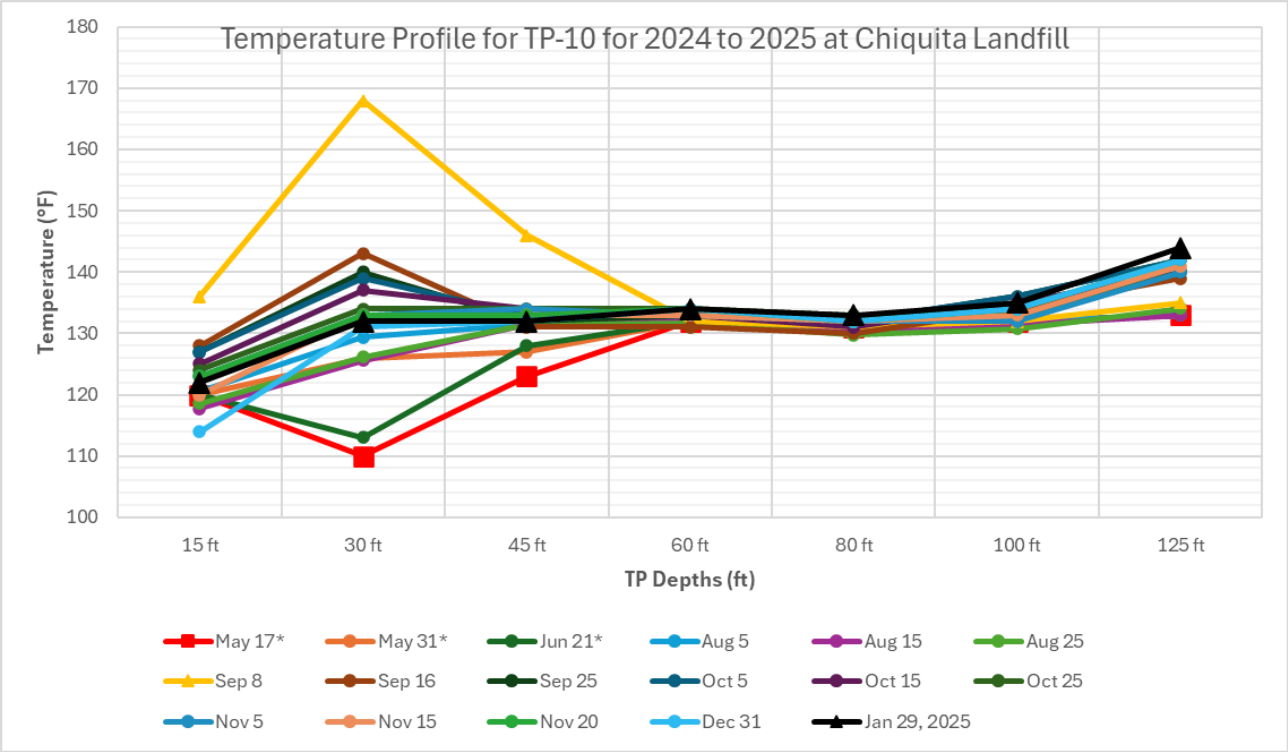
19, TP-20) have temperatures that have been or are currently trending upwards since installation. The remaining ten are holding their current temperatures and have not cooled. Two TMPs (TP-6 and TP-8) have seen both increases and decreases. TP-6 reported a significant temperature decrease in the deeper probes at depths of 80, 100, and 120 ft; however, it also observed substantial temperature increases in the shallow probes at depths of 15, 30, 45, and 60 ft. TP-8 recorded substantial temperature increases on January 10, 2025, once TP-8 came back online. The CCL elected to take TP-8 offline in early October 2024, for a waste filling process. Temperature differentials of 30 to 90°F were observed in all TMPs. Two probes in TP-8 recorded temperatures of 230 to 232°F (110 to 111°C). Since January 2025, all temperatures have dropped, but not to the original temperatures measured in May 2024. As of April 2024, the two TMPs (TP-3 and TP-9) in the original waste area have maintained their maximum temperatures at 222°F (105.5°C) and 233°F (111.6°C), respectively. Attachment B provides graphs of the ten TMPs that have demonstrated or are currently experiencing temperature increases.
